Disaster and Failure Studies

Pentagon Building Performance Study 2001

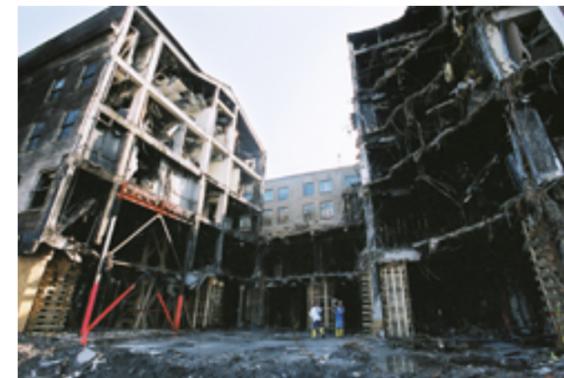
Arlington, VA, September 21, 2001 -- The exterior of the Pentagon crash site is shown after the area has been stabilized by shoring structures. (Photo by Jocelyn Augustino/ FEMA News Photo)
